RE: Revisions to Site Investigation Report
Wiley's Garage, South Londonderry, VT
TSEC Project No. 93-010
SMS Site No. 91-1027

REVISED SITE INVESTIGATION REPORT

WILEY'S GARAGE
S. LONDONDERRY, VT
SMS SITE NO. 91-1027

AUGUST 27, 1993

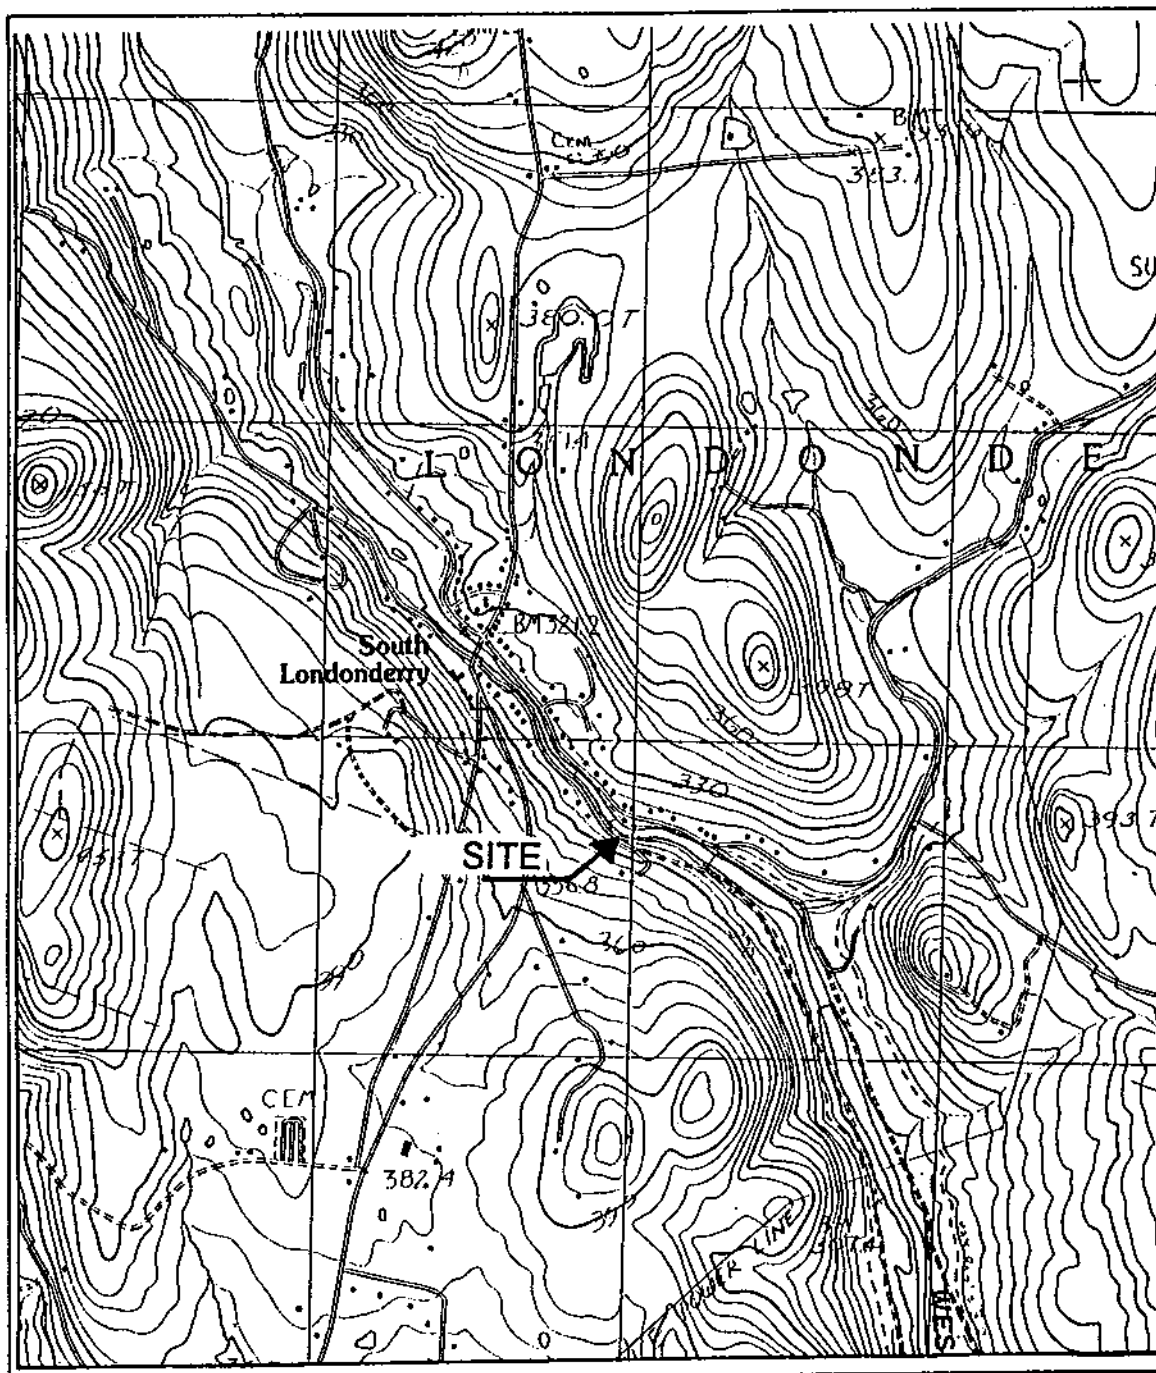
FIGURE #
1

The Site Plan provided as Figure 1 illustrates the current site layout and additionally identifies the approximate locations of the three (3) former USTs.

Subsurface soils were evaluated visually and with the use of a PID at three (3) on-site locations through the installation of soil borings. One boring was additionally converted to a monitoring well in order to facilitate the generation of data representative of groundwater conditions underlying the site. The approximate locations of the soil borings (SB-1 and SB-2) and the surveyed locations of the newly installed monitoring well (MW-3) and the previously existing monitoring wells (MW-1 and MW-2) are depicted on Figure 1.

In order to generate information necessary for the periodic determination of groundwater flow relative to this site location, all three monitoring wells located at the site were surveyed for location and elevation data. This data has been incorporated into the Site Plan provided as Figure 1.
